Thermal Control Materials on MISSE-5 With Comparison to Earlier Flight Data

National Space and Missile Materials Symposium Keystone, CO June 2007

Materials on International Space Station Experiment (MISSE) - 5

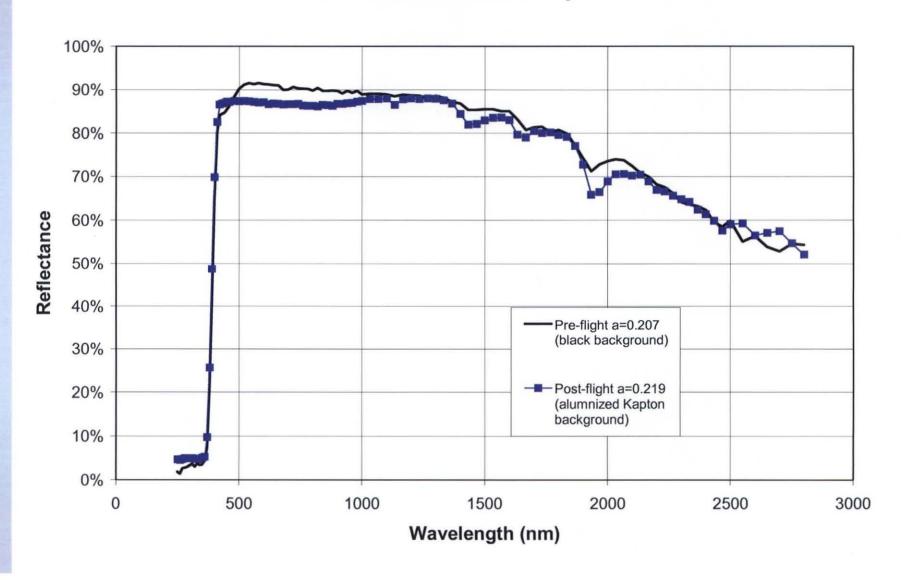
MISSE-5 AZ93 on Kapton

AZ93 on Kapton

- Thinner layer than aluminum substrate
- No indication of contamination at 400 nm knee

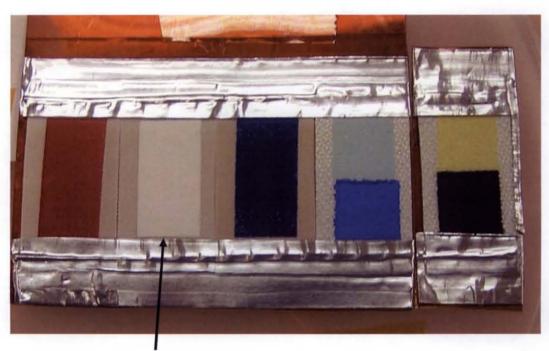
MISSE-5 AZ93 on Beta Cloth

AZ93 on Beta Cloth looks white. Change in reflectance spectra may indicate darkening of beta cloth underneath coating.

No Aluminization

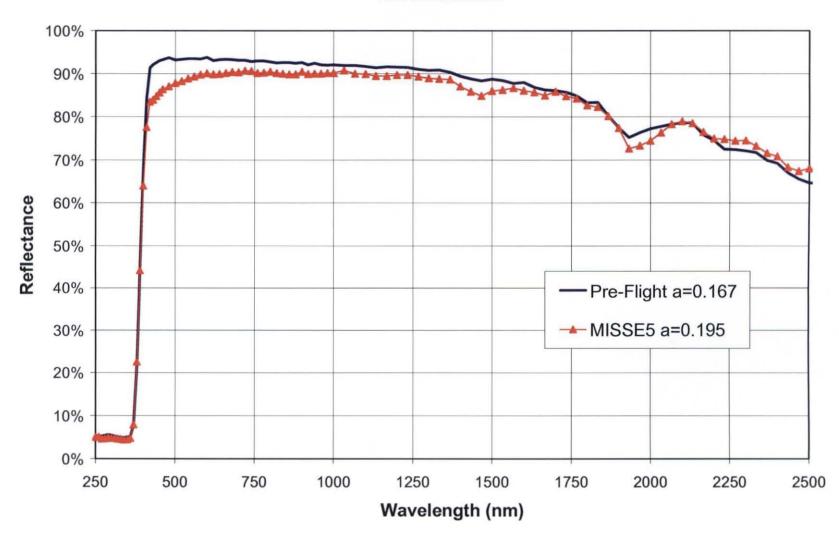
AZ93 on Beta Cloth

AZ93 on Kapton

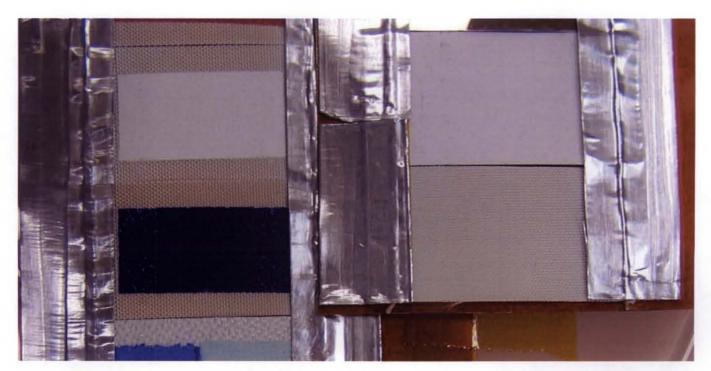
AMJ-700IBU on Beta Cloth

Aluminized Beta Cloth

Darkening of beta cloth without darkening of AZ93 indicates more UV radiation than expected.

Darkening of this level has been simulated with 500 – 800 ESH in lab.

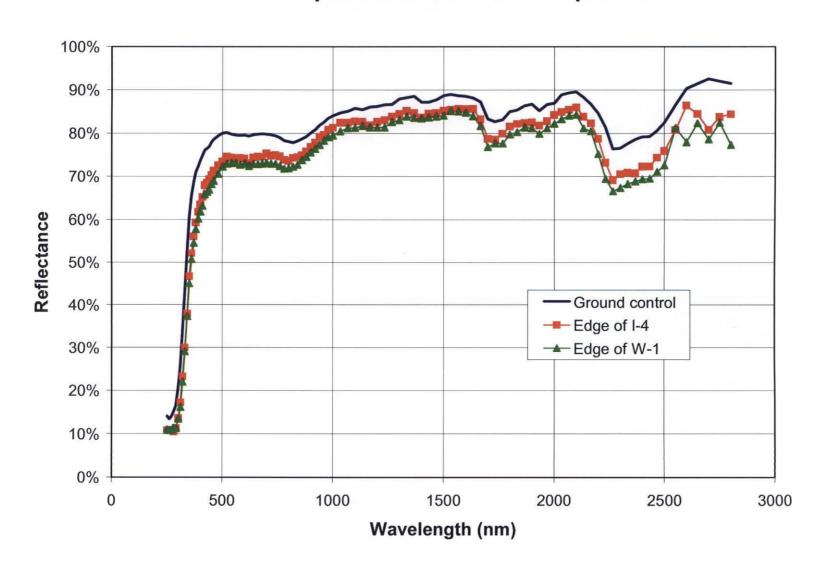
Dutch Space Glass Cloth on Kapton

These coatings (on aluminum) also performed well on MISSE-1 and -2. Some MISSE-5 marker coatings were screen printed on Dutch Space glass cloth/Kapton film

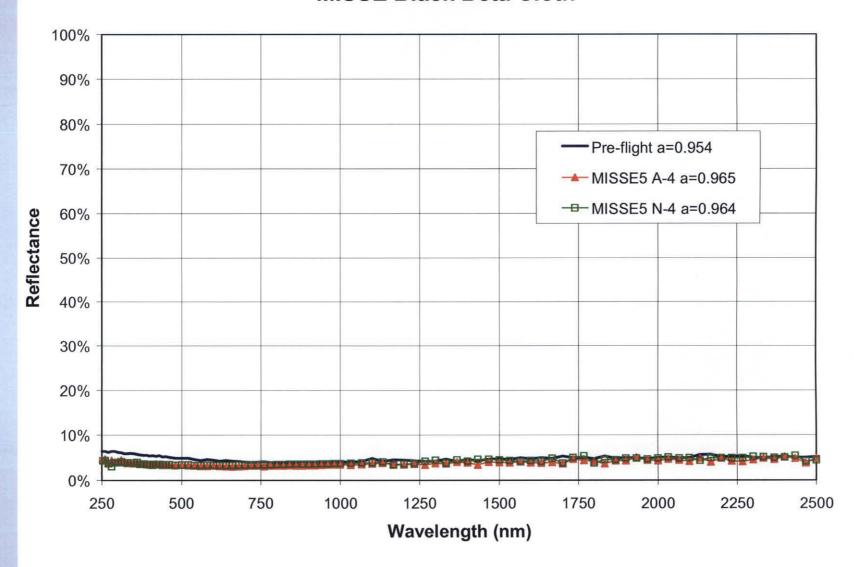
MISSE Black Beta Cloth

Black beta cloth

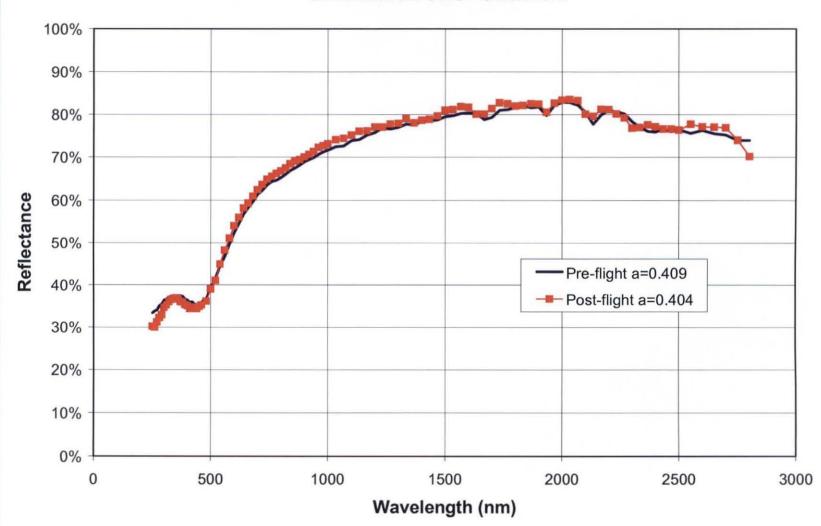
MISSE-5 SiO / Kapton E / VDA

Candidate for JWST Sunshield

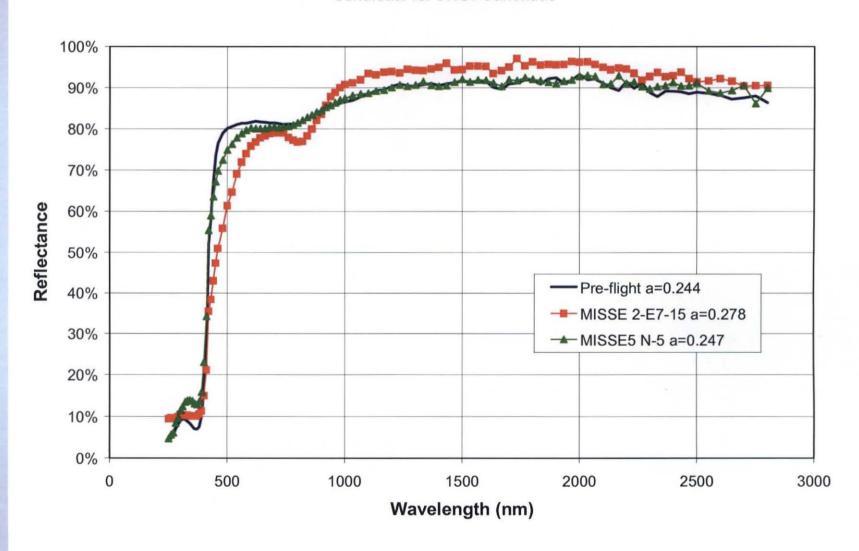
SiO / CP1 / VDA

Note: sample was exposed to UV and no AO through magnesium fluoride window

Candidate for JWST Sunshade

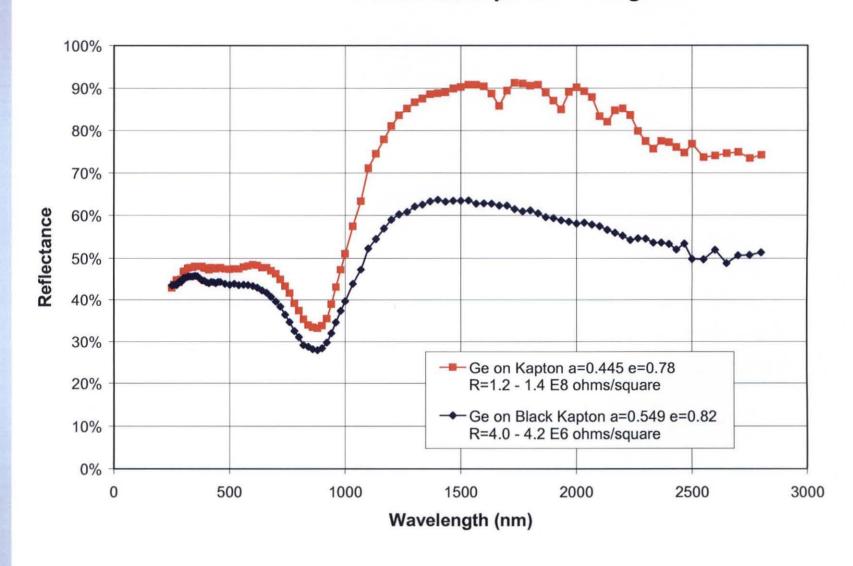
MISSE-5 Germanium/Kapton Post-flight

Germanium on Kapton and black Kapton Similar materials flown on Passive Optical Sample Assembly
